# Technical Report

(Kimbutan MHP Project Upgrading)

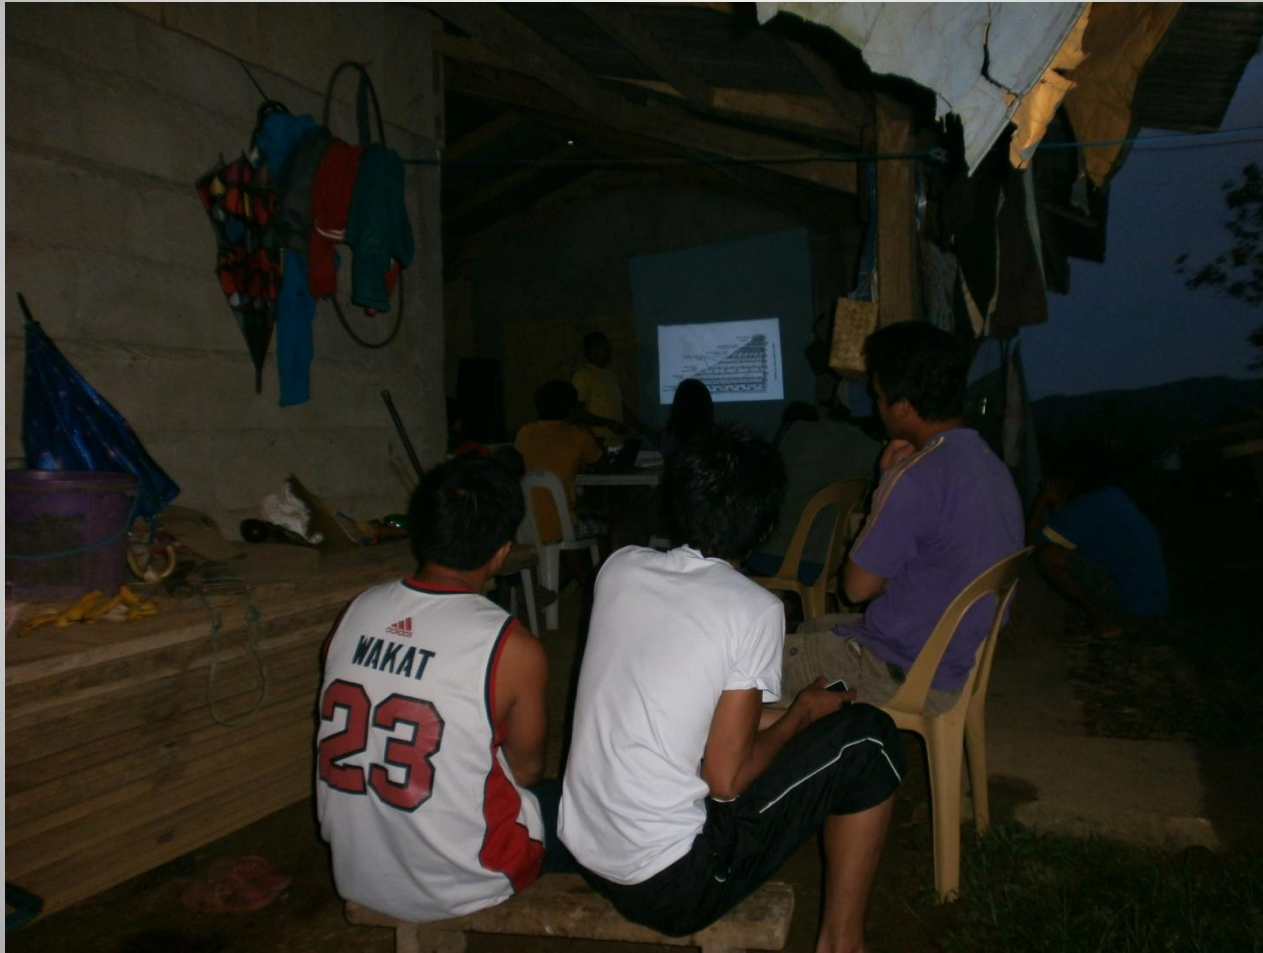
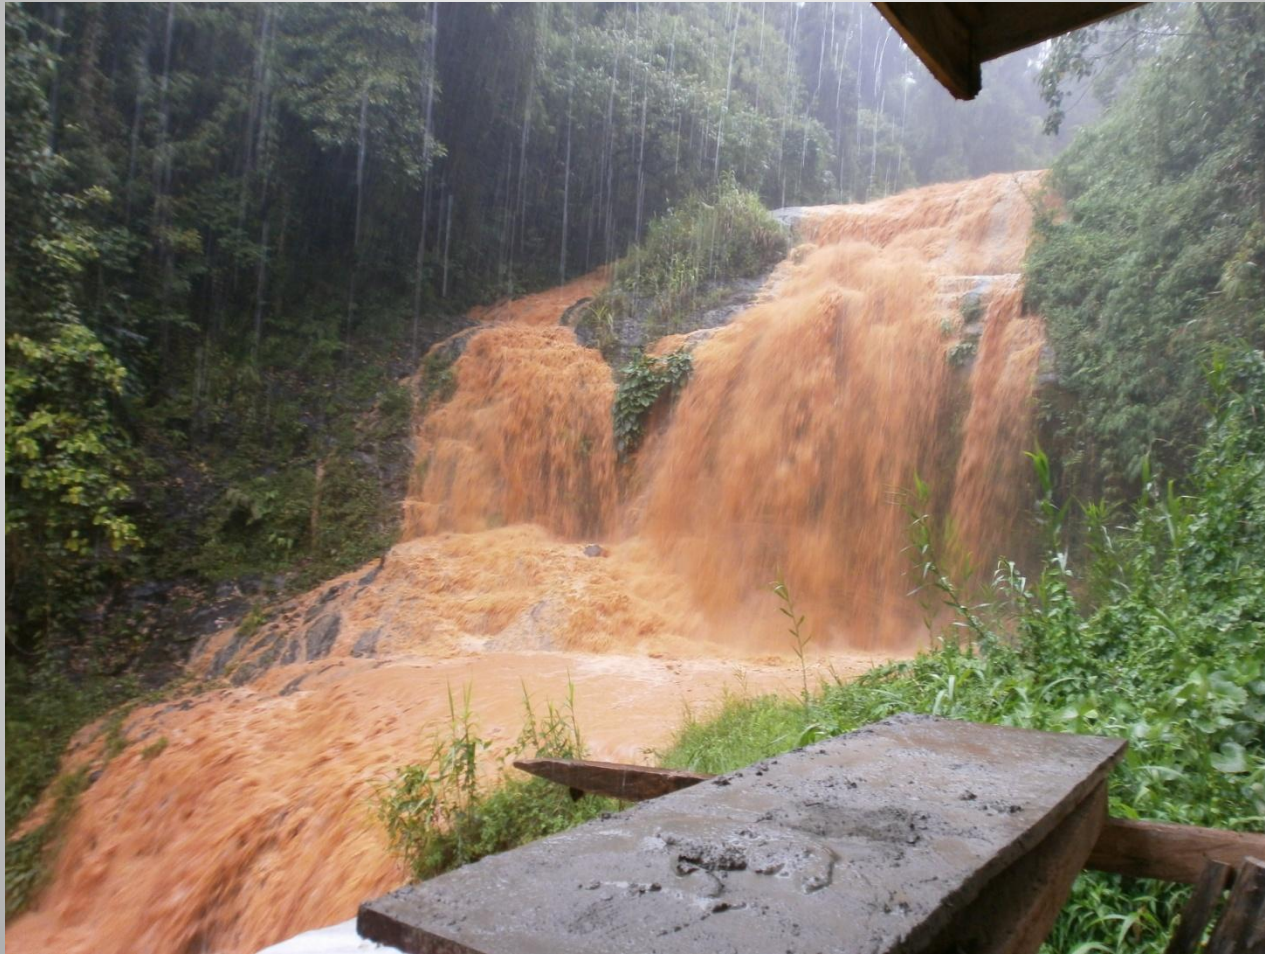
Brownish flowing water showed excessive siltation indicating there are denuded spots inside the watershed perimeters

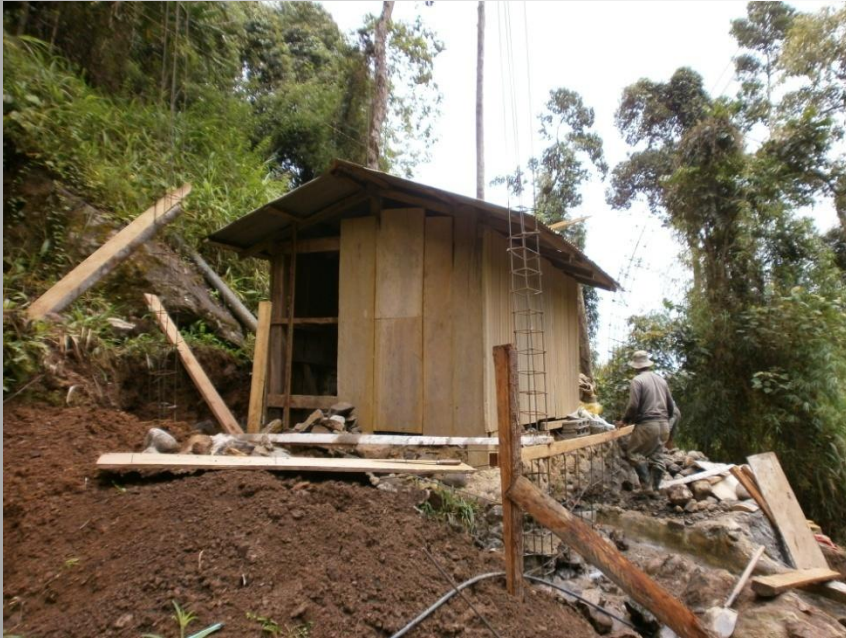
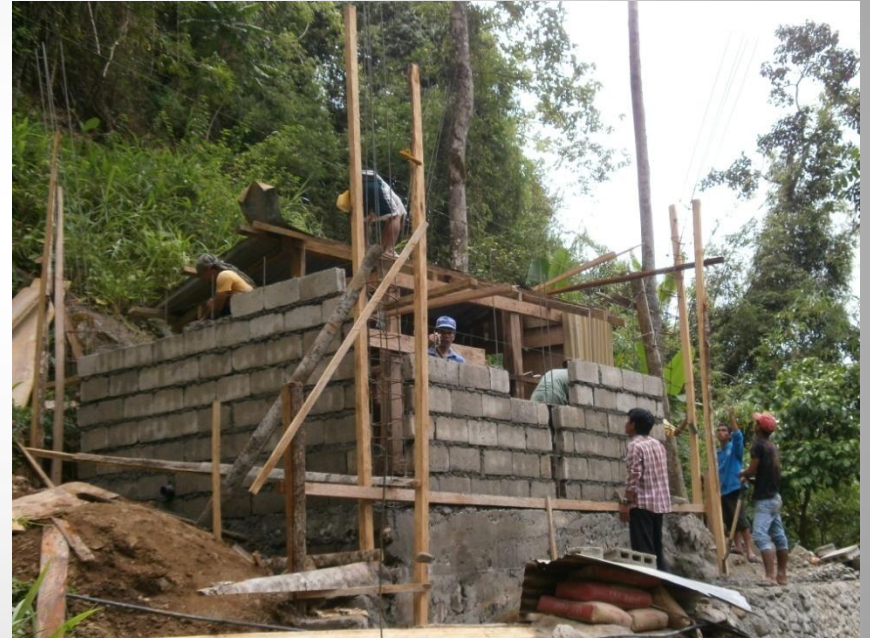
# Powerhouse Modification

# Remodeling the power house from wooden to concrete make .

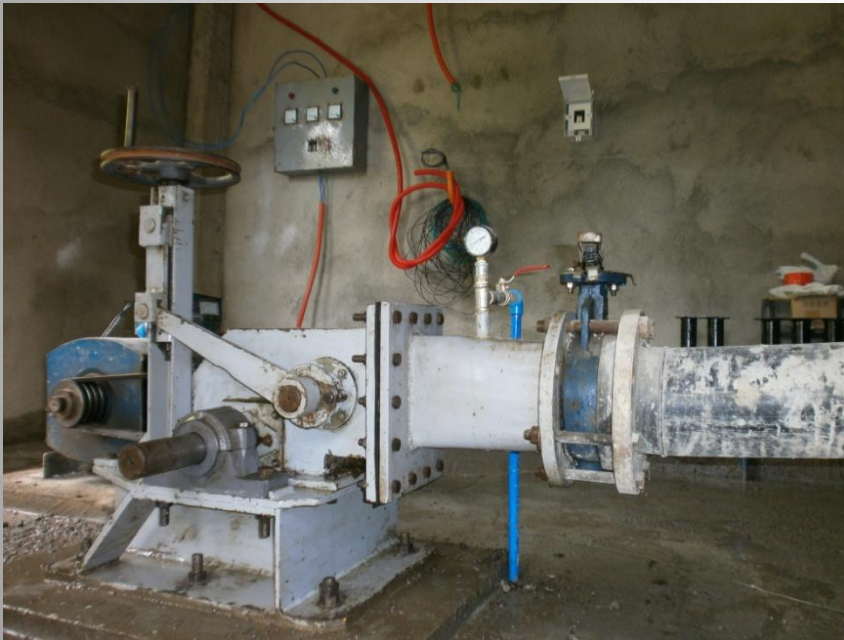
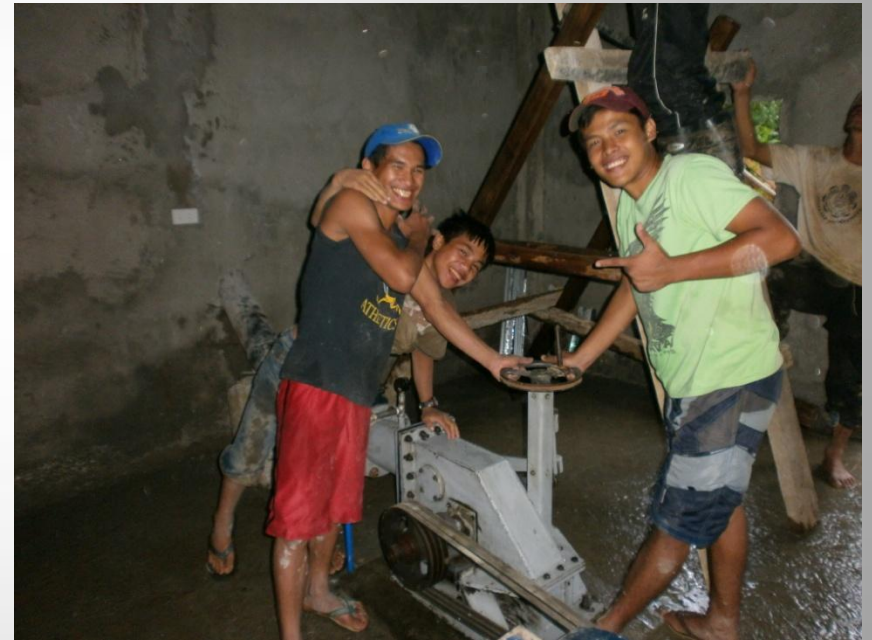
# Installing electro-mechanical components

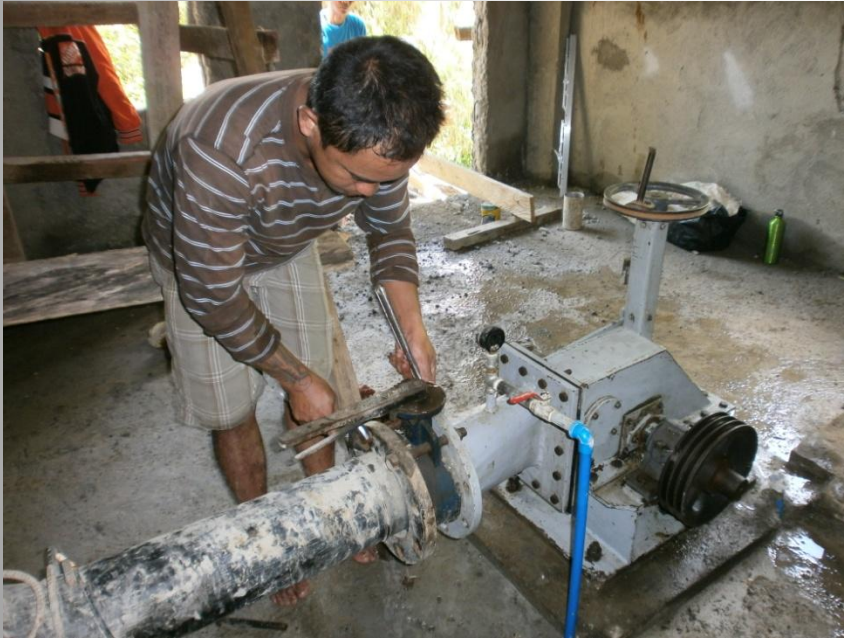
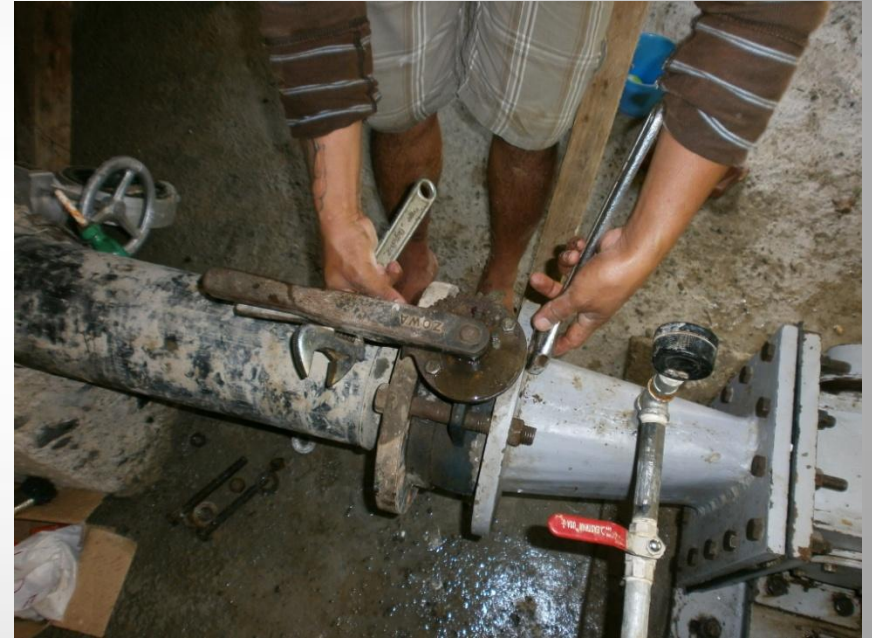
# Valve Replacement

New butterfly valve(Geared type) was installed  
and existing turbine repainted.

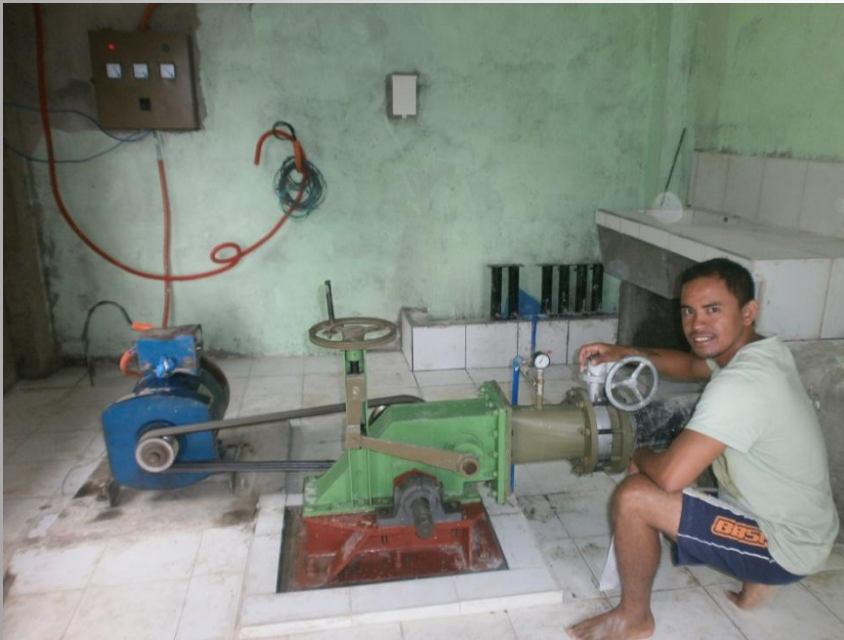
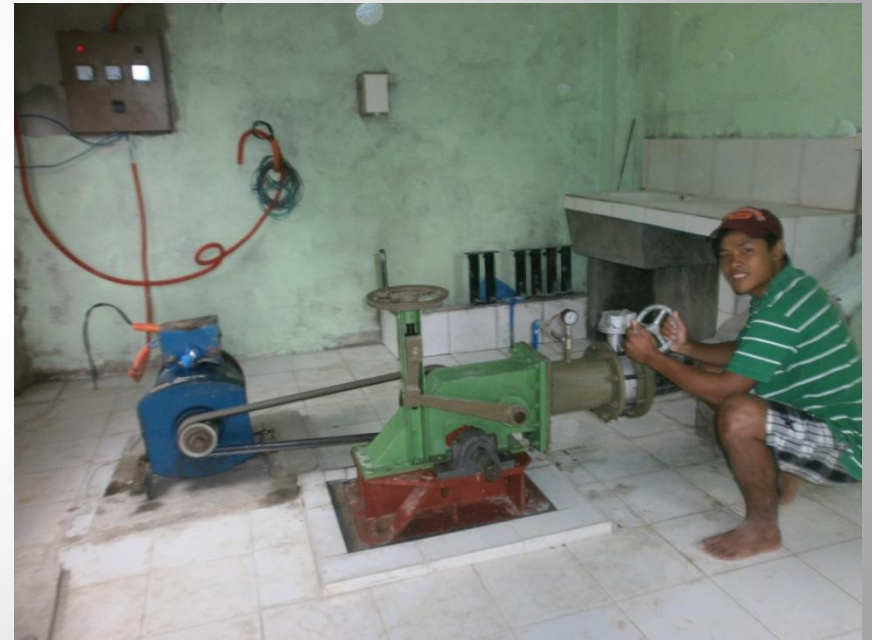
# Electro-mechanical devices getting a face-lift after repainting

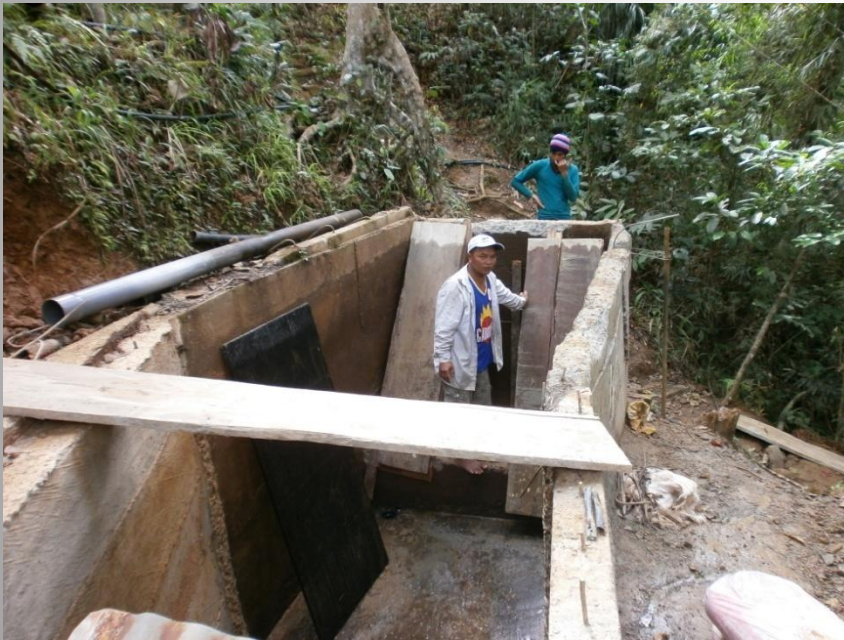
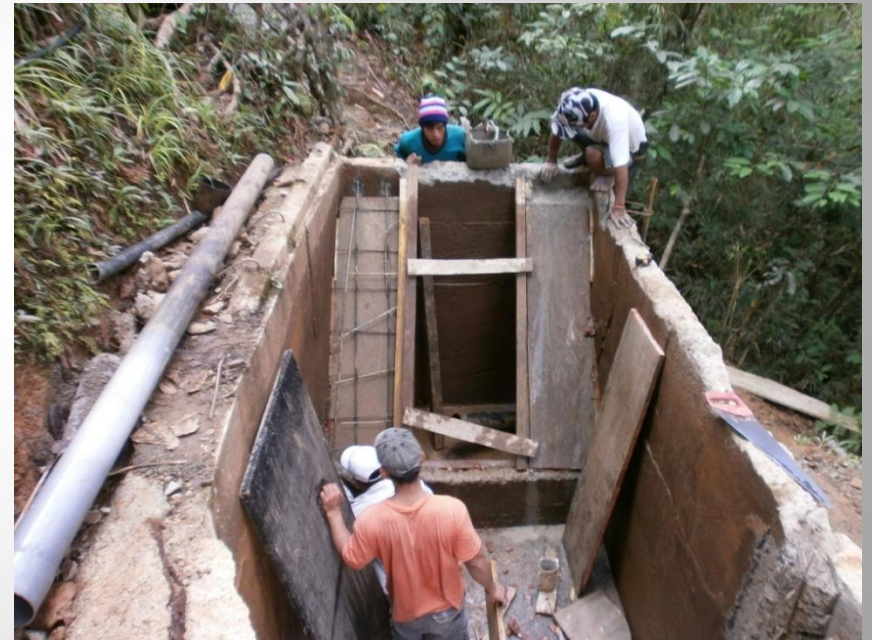
Installing the trashrack in the forebay tank for the protection of the turbine.

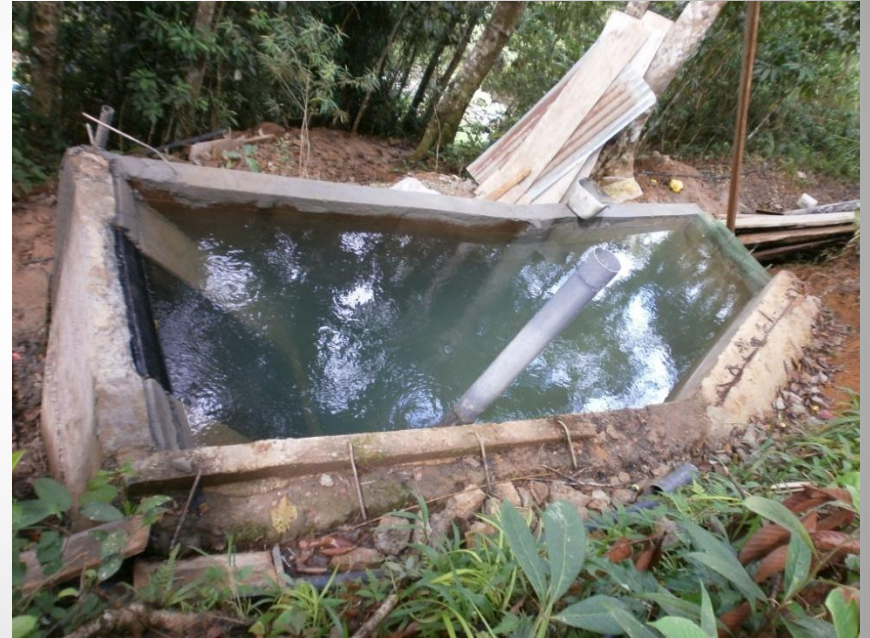
**After**

# Expanded Forebay

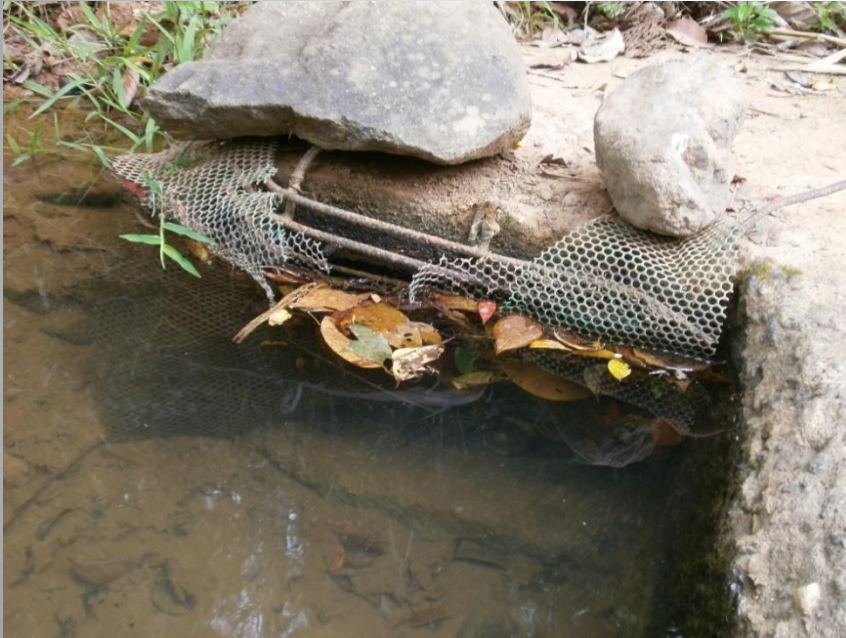
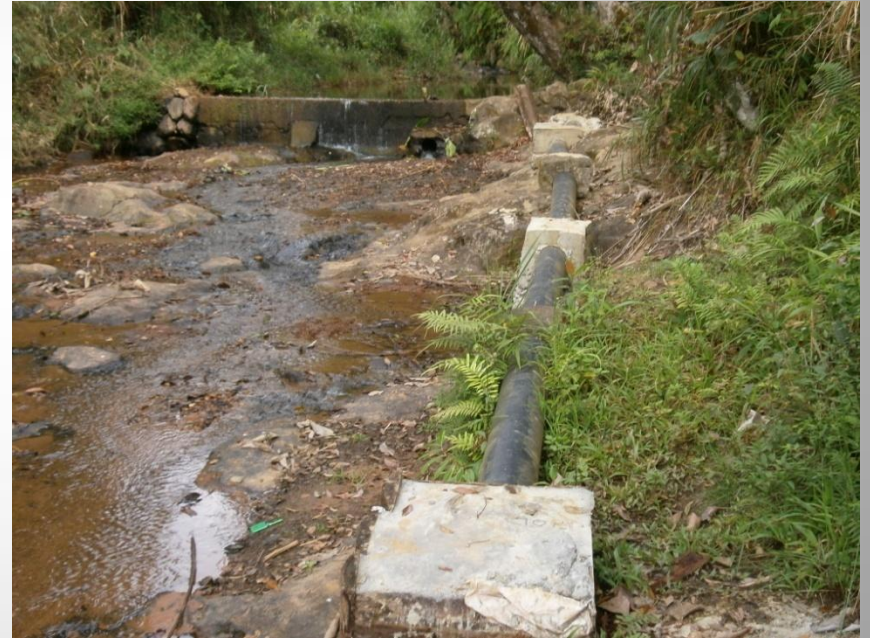
# Intake

# Installing a breather from the headrace pipe going to the forebay.

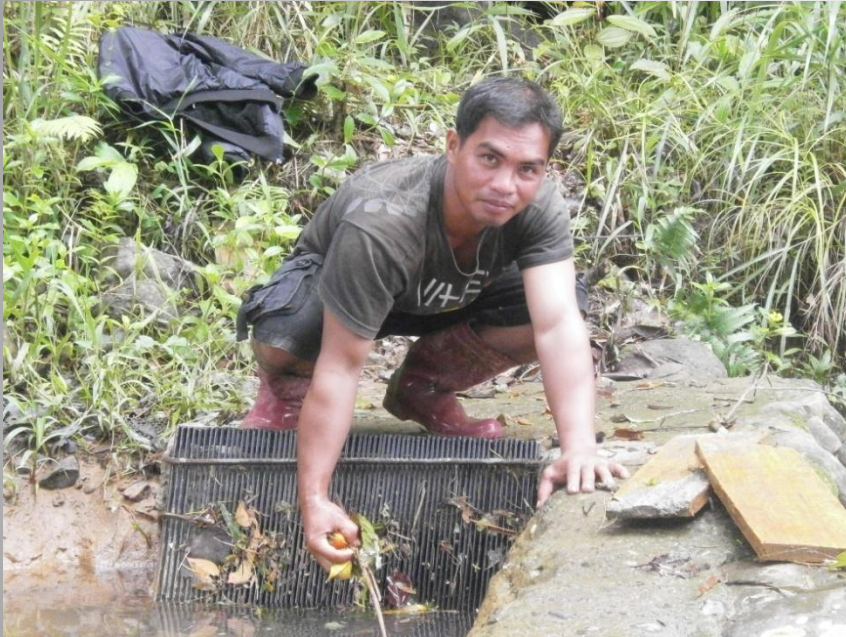
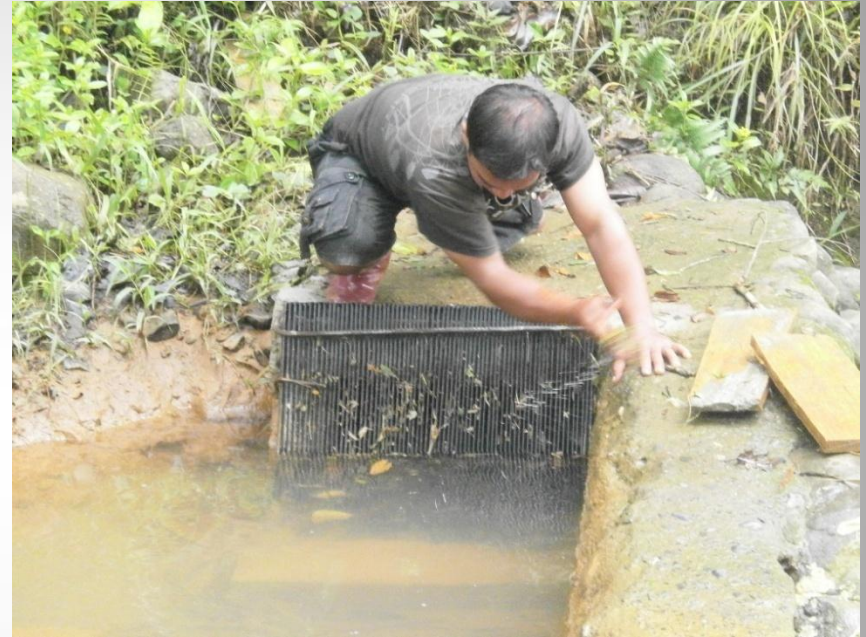
Installing a fabricated screen to the intake for the protection of the headrace pipe going to the forebay tank.

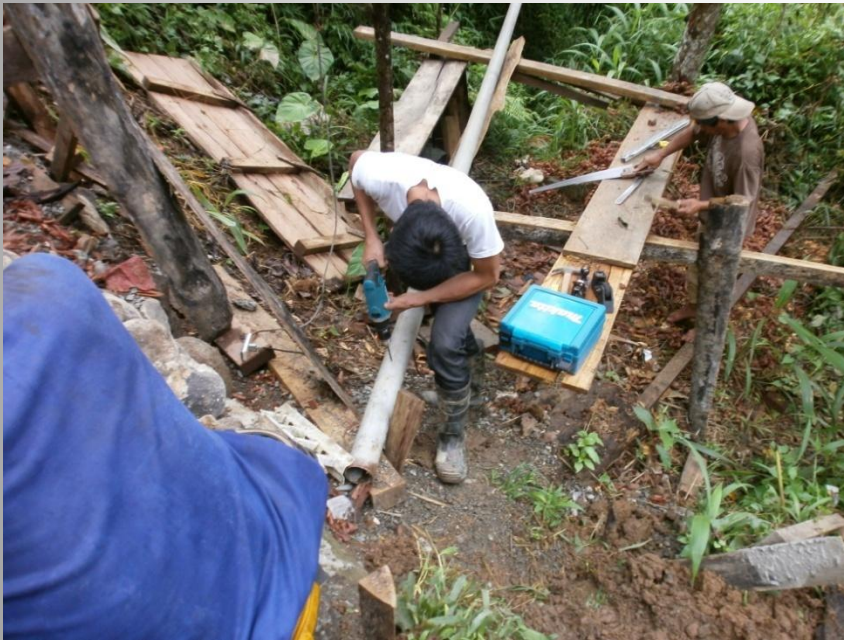
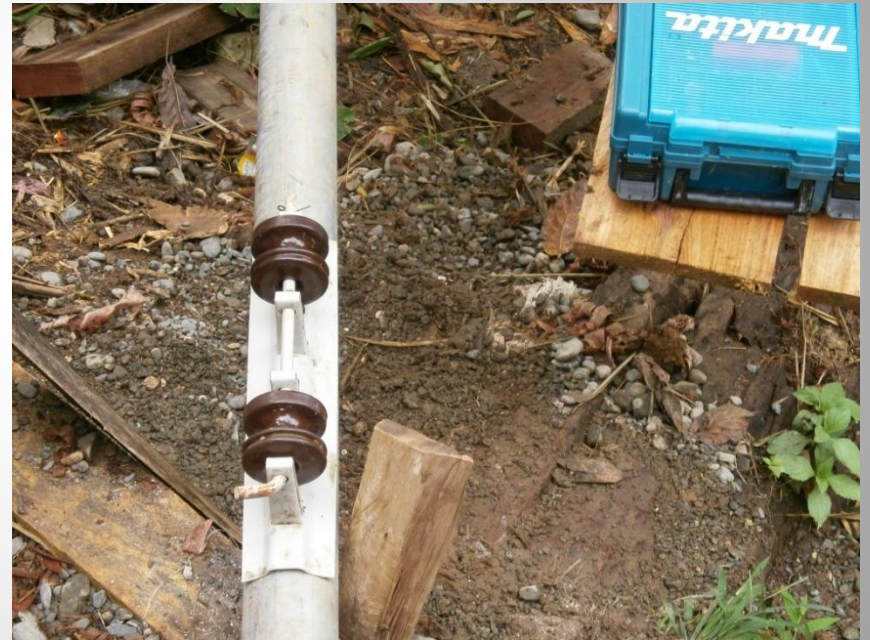
# Line Posts: replacing previous wooden ones with GI steel

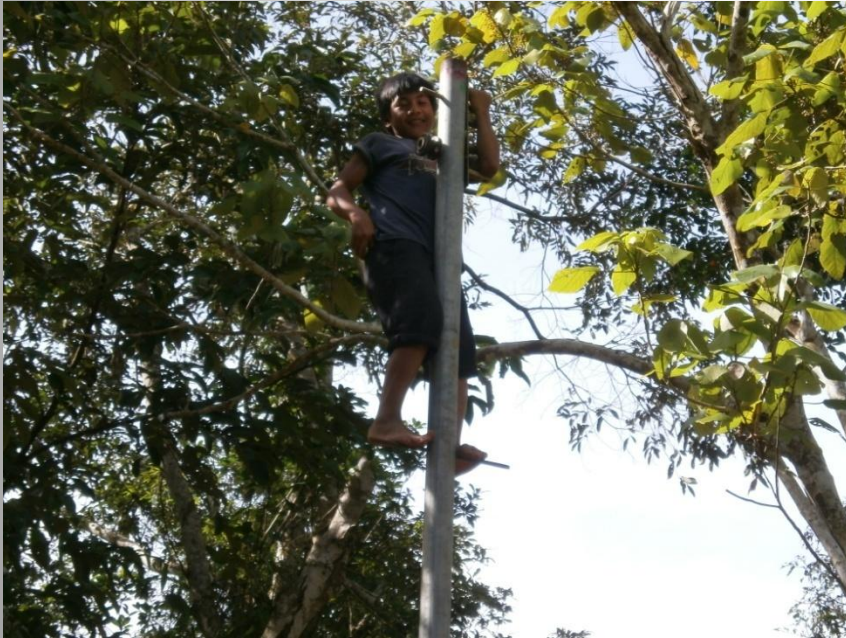
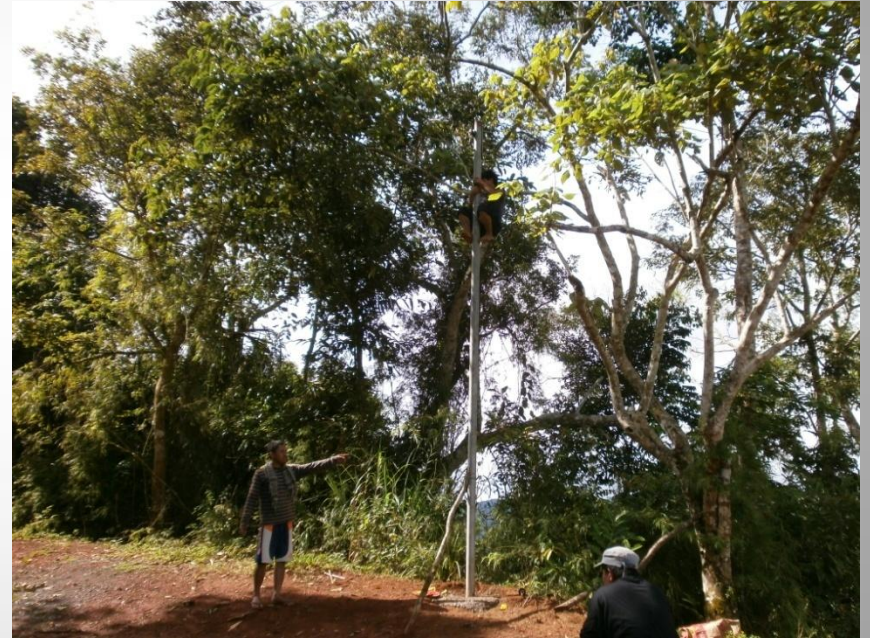
# Installing the insulators from the steel posts
