**WATER AND WASTEWATER IMPROVEMENTS
AT JUSTINIAN HOSPITAL**

**MINISTRY OF HEALTH NORTHERN DEPARTMENT
CAP HAITIEN, HAITI**

**KONBIT SANTE
PORTLAND, MAINE**

01 JULY 2009

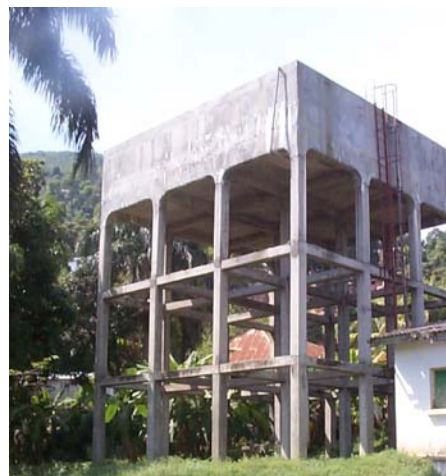
42,500-Gallon Elevated Storage Tank

illustrates a simplified diagram of the HUI water system at the start of the project. The hospital relied on a single 320-foot deep bedrock well since the municipal water supply ended years ago. The water was pumped to a 42,500-gallon elevated concrete storage tank through a galvanized steel pipe, which passed through a medical waste pile. Water from the storage tank flowed by gravity through a distribution

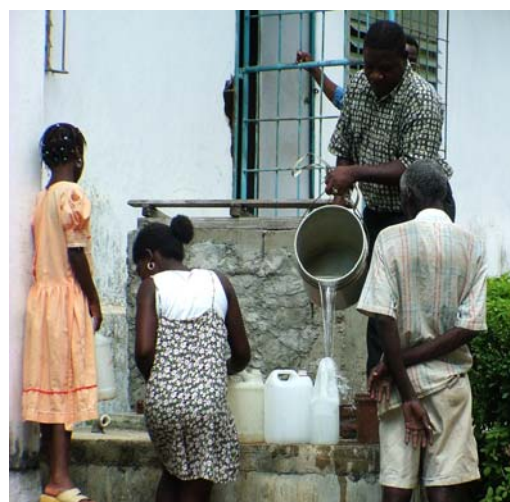
Drawing water from in-ground reservoir

During power outages and for buildings or areas that are not served by a rooftop tank, hospital workers draw water by hand from the in-ground reservoirs and fill drums located at the points-of-use. The hospital staff notified the water system operator when they needed water and he delivered it. The reservoirs were otherwise locked to prevent unauthorized access.

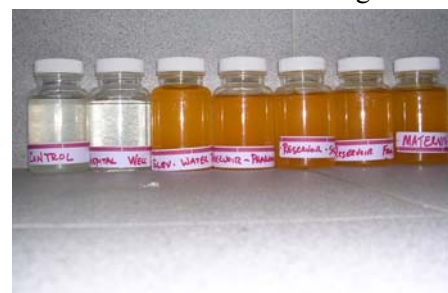
Tests Show Hospital Water is Contaminated with Coliform Bacteria (Yellow Jars)

Bacterial analyses found the well water was free of contamination, but all of the water in the distribution was contaminated, including the storage reservoir. Fecal contamination was found in many samples collected from sinks in the hospital. One of the sources of contamination was thought to be the galvanized pipe that passed through the medical waste pile. At a loss of power, the water drained back into the well, creating a vacuum that could suck contaminated groundwater into leaking pipe joints. This could explain how the well water tested clean and the tank water contaminated.

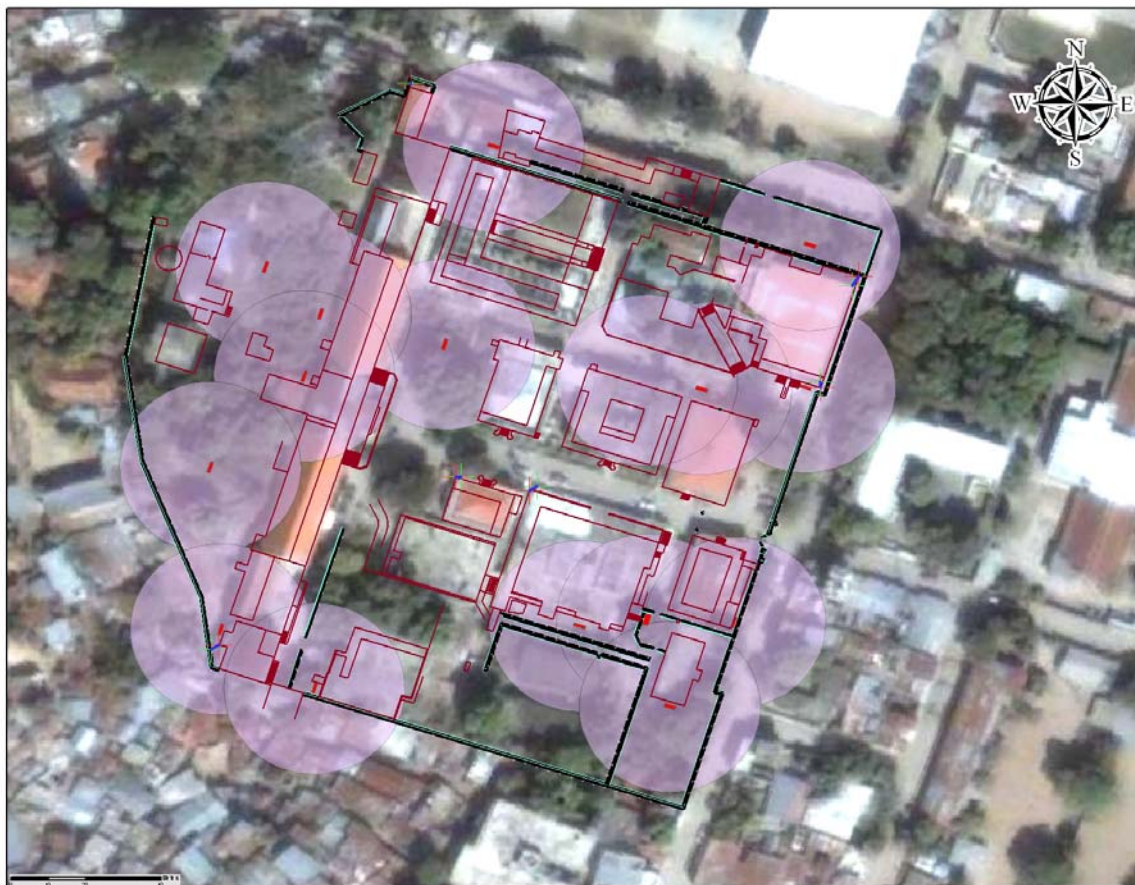
Figure 2 25-Meter Zones around Cesspools and Latrines Limit Viable Areas for New Wells

Disposal of partly treated wastewater risks contaminating the groundwater and hospital water supply. In the U.S., wells are typically kept 25 meters from wastewater leach fields. Figure 2 illustrates the hospital property with magenta-colored circles extending 25 meters from each latrine and cesspool. The building outlines are in red. There is limited space on the hospital property that is open (i.e., no building), accessible, and outside the zone of possible contamination.

Aerial photograph from Google Earth

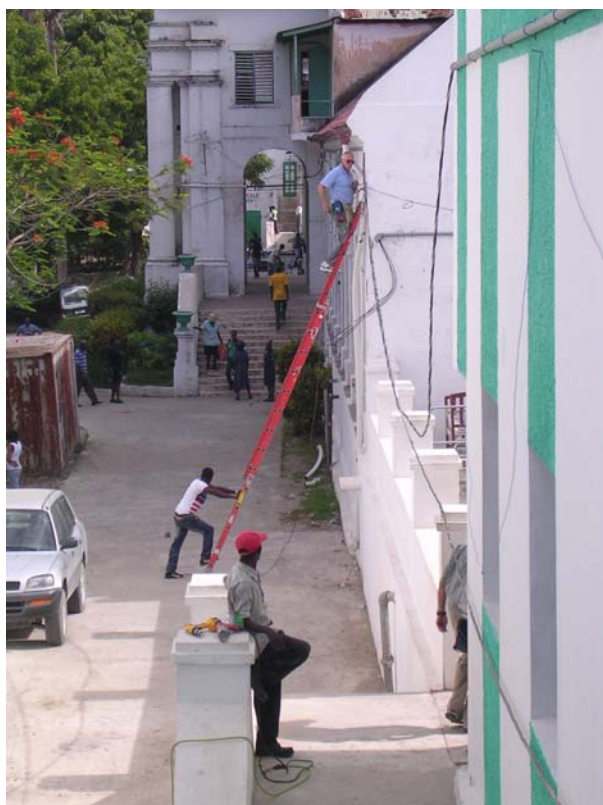
New Electrical Service

Work in the summer of 2008 focused on maximizing the output of the existing well. Volunteers and hospital staff installed a new electrical service for the existing well. The improvements included a backup power supply and equipment that allowed the pump to run on generator and the municipal power supply. Hospital staff were very pleased with the improved supply, but the volume was still inadequate for all the various needs.

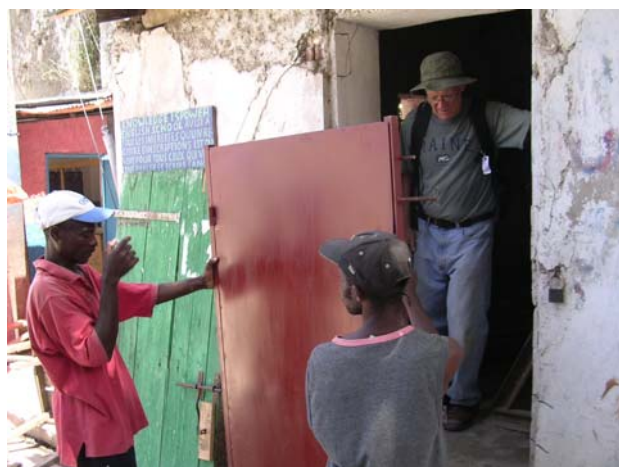
Installing New Door on Pump House to Protect Control System

We contracted with a Haitien builder to construct a masonry pump house, which provided a secure and weather-tight enclosure for the backup power supply, pump controls and disinfection system.

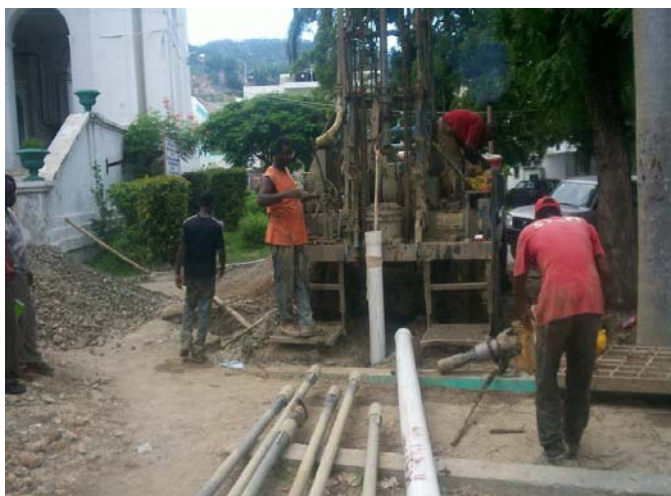
Drilling the New Well at Hospital

In September 2008, a new well was installed. Konbit Sante worked with the United Nations to locate the well and the UN covered the costs for drilling the well and installing the pump. This saved money for additional improvements to the distribution system.
