## **“GABION BANDS”:**

### **A Proposed Technology for Reconstructing Rural Rubble Stone Houses after the 2015 Nepal Earthquakes**

By Randolph Langenbach, August 27, 2015

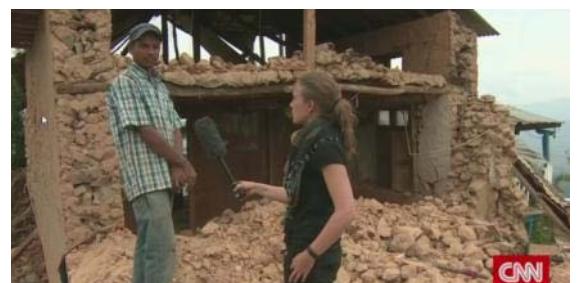
Collapsed house showing horizontally bedded rubble stone construction in Gorkha District. (web)

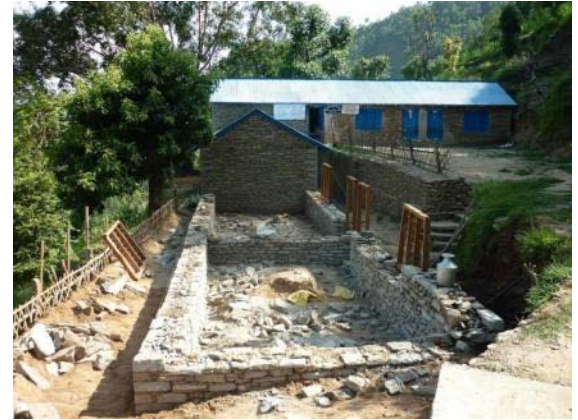
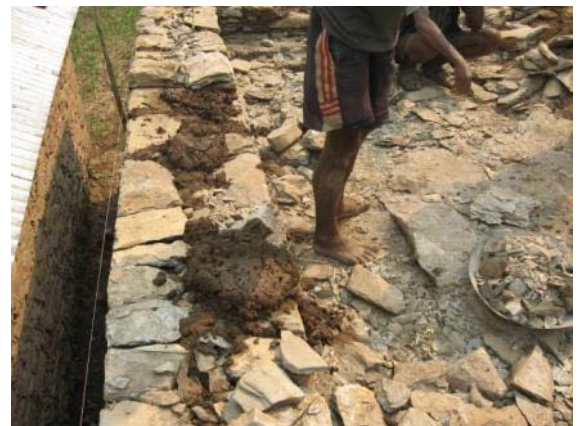
Photos by Prem K. Khatri of school construction in Gorkha district.

The school shown being constructed in photos by Prem K. Khatri shown in the photo on the right is being done with a degree of masonry expertise, and that the walls consist of flat stones that are roughly dressed (the term “dressed” in stone masonry means tooled and shaped so that the stone can be properly bedded in horizontal layers or ‘courses’). The mortar is clay without added lime (and thankfully, no Portland cement). The walls appear to have rubble cores between the inside leaf and outside leaf, each of which are one stone thick). Almost all of these rural rubble stone houses completely lack bond courses, as such would result in walls which are not smooth. The roofs are constructed with rafters resting on the walls and a ridge beam that is often not well attached to the stone gables at either end.

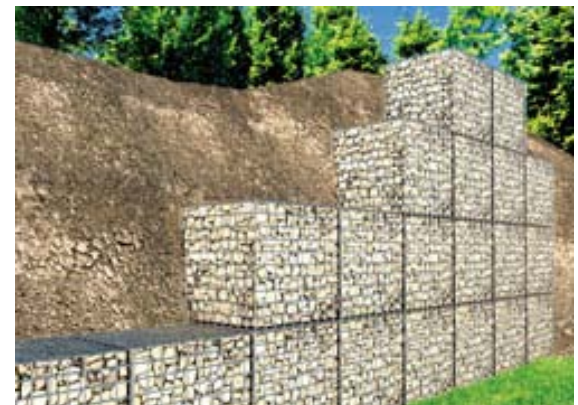
Photos from web of gabion basket retaining wall (above). The photo below shows how inconspicuous the wires can be if the basketing is of only a single layer of stone.

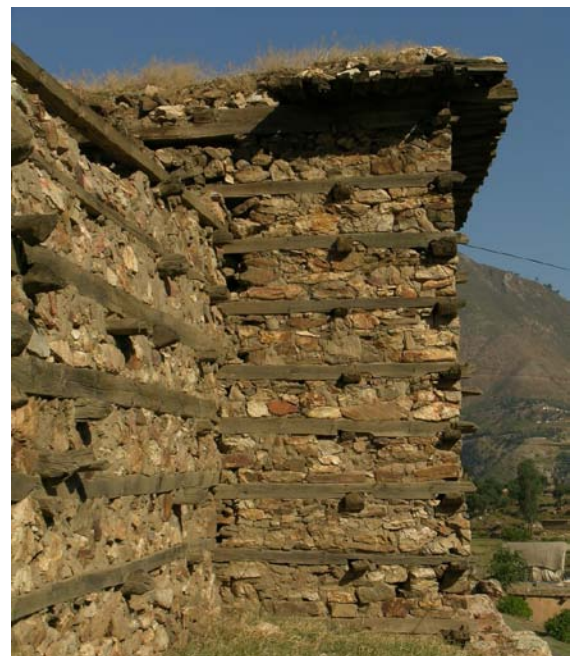
A 19<sup>th</sup> century timber-laced rubble stone fort in Northern Pakistan near epicenter of 2005 earthquake that killed 89,000 people. It survived with very little damage despite having been abandoned and unmaintained for half a century! (Photo by author)

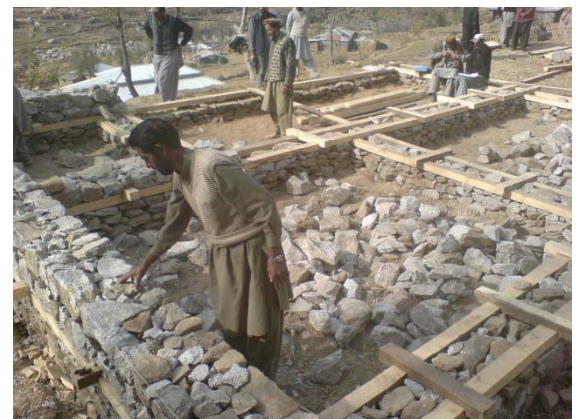
Example of new building being constructed with timber bands in Pakistan after the 2005 earthquake. The gabion bands proposed here would lay into the wall and overlap in a similar way. (Photo by Tom Schacher)

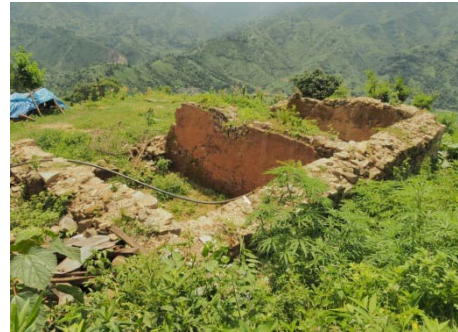
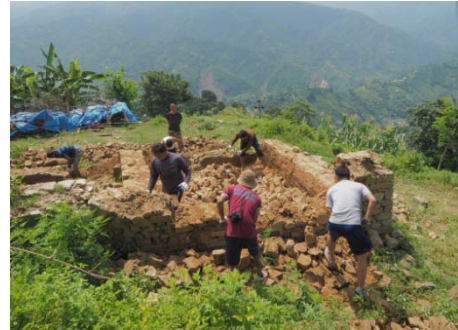
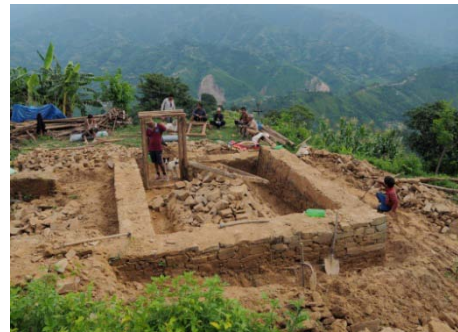
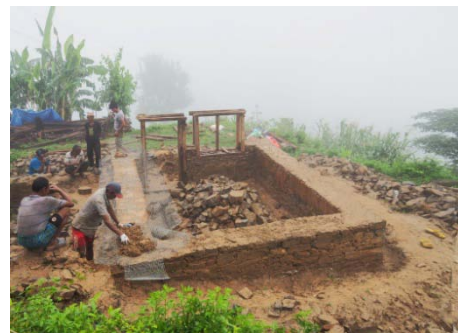
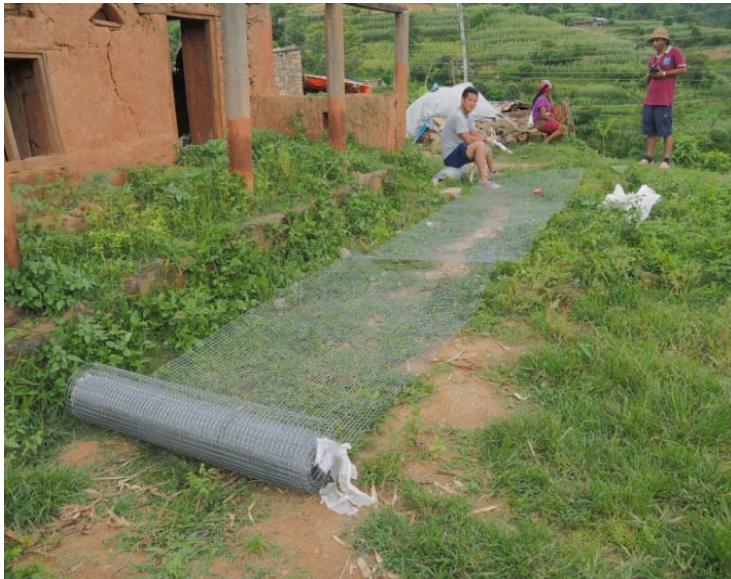
The photographs on the right show the progress of the project from the initial demolition of the ruins to a common height, and the reconstruction of the house with the welded wire-mesh bands (ring beams). Below you can see the laying out and cutting of the wire mesh to size, and then in the 3<sup>rd</sup>, 4<sup>th</sup>, and 5<sup>th</sup> pictures on the right, the laying out and wrapping of the bands is visible. The corners are interlocked by wrapping the ends of the two bands back onto themselves such as both bands form a single ring around the corners of the structure.

The process proceeded as follows: (1) At the level of a band, one would simply unroll the fencing wire along the partially completed stone wall, overlapping it if the role runs out and pieces must be joined together. (2) Add one more course (single layer) of stone masonry in mud mortar following the same craftsmanship as one has done already, (3) Bend the wire up and over this new layer of masonry, with the wire from one side overlapping the wire fencing from the other so that that one layer is inside a tube of wire tightly drawn together. Short pieces of galvanized wire can be used to tie the two sides together where they overlap with a simple twist, and to tie the gabion bands together at the corners where they overlap. (5) Then, carry on until the next band with the stone masonry work.

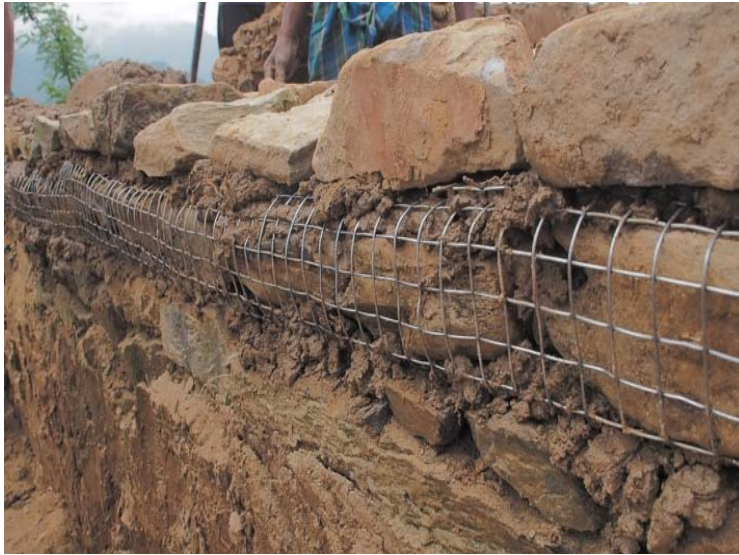
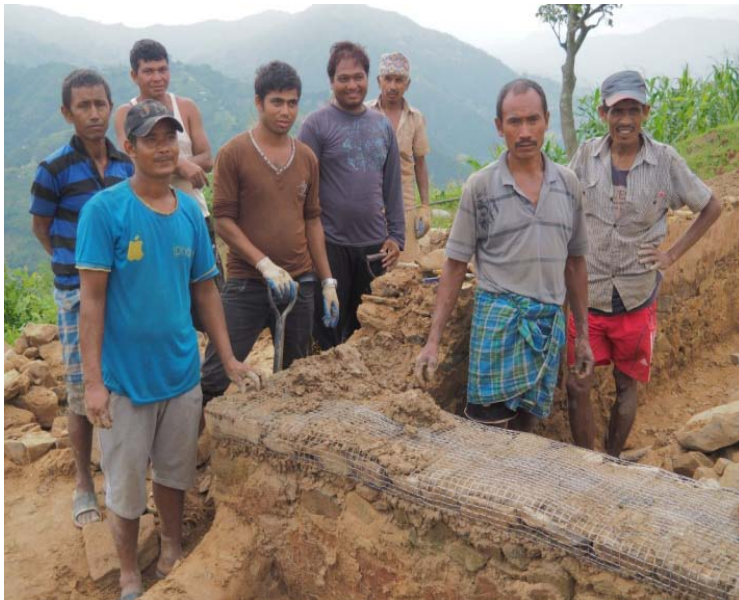
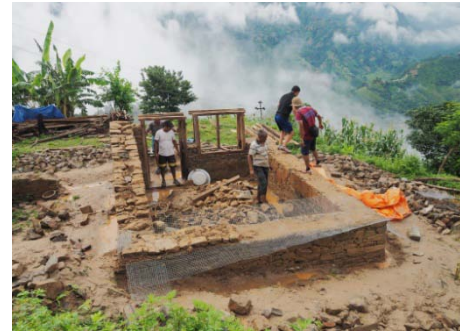
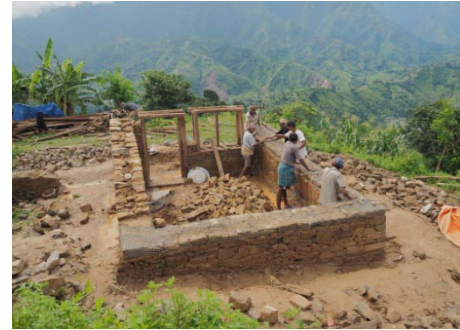
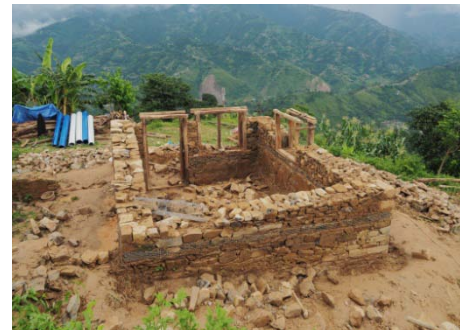
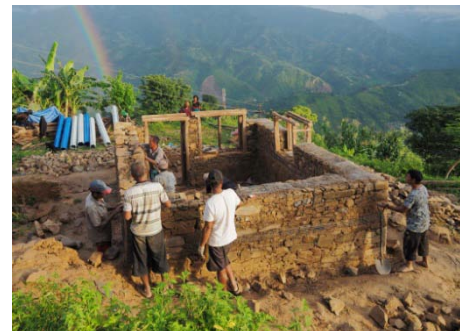
The wrapped band can be seen in the picture below. When the house is completed, this wire band can be plastered with mud plaster. In the photograph below that, the family and team of masons from the community is shown who built the house, which was completed as a shell in just 4 days. The roof is shown as it was placed only temporarily on the structure during the documentary filming, but the intention is to install it permanently on timber rafters, and perhaps in the future to add a second story.

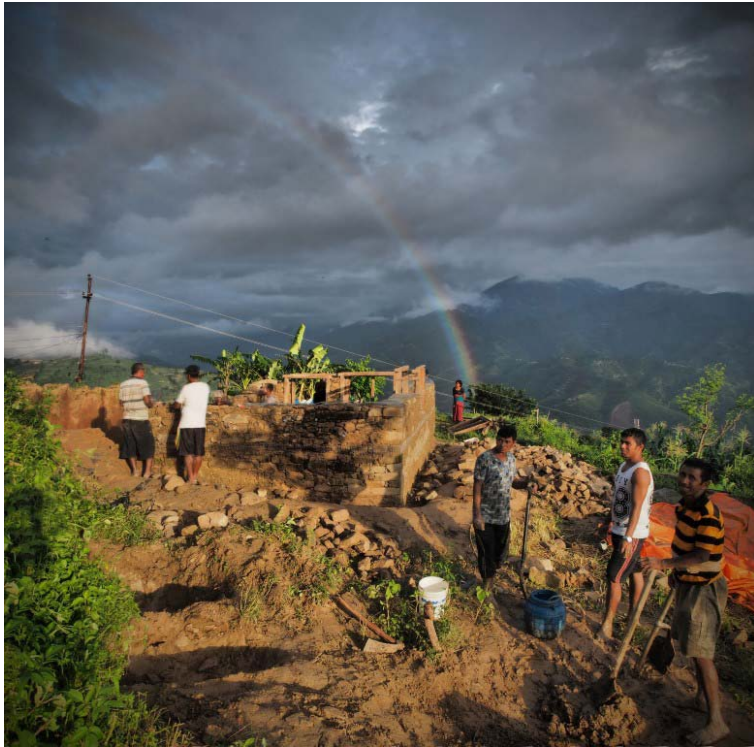
In addition to the installation of the bands, the wire mesh was used to fabricate a beam with stones inside so to span the corner to support a simple chimney, and so to address the usual problem found in many houses where the kitchen stove is an open fire filling the kitchen with smoke.
