Implementation – Pre-Trip Plan

Executive Summary	
Community:	Village of Gasiza, Cyanika Sector
Country:	Rwanda
Chapter:	University of Colorado Boulder
Submittal Date:	February 2, 2020
Authors:	Cassidy Cortright, Anthony Pimentel, Jack Harris, Lucas Batista, Sean Connelly, Erik Rhodes, James Douthit, Michaela Alkire, Annamarie Guth, Casey Bangs, Ryan Tasto, Carrie Bishop, Ashley Merrill, Whitney Knopp, Anna Lynton
REIC and other mentors:	Cole Bedford (REIC, Civil Engineer), Kara Lentz (Travel Mentor), Lydie Uwantege, Travis Grieman.
Scope of Work for the project (50 words) ¹	Design and implement a rainwater catchment system with 6,000L capacity in the village of Gasiza, within the Cyanika Sector of Rwanda. Our team has an ongoing project in the Cyanika region with a promise to design and build 12 rainwater catchment systems. This will be the sixth system implemented.
Scope of Work for the trip (100 words) ²	This will be the sixth implementation trip for the rainwater catchment project in the Cyanka region.

Rainwater Collection System Gasiza Rwanda

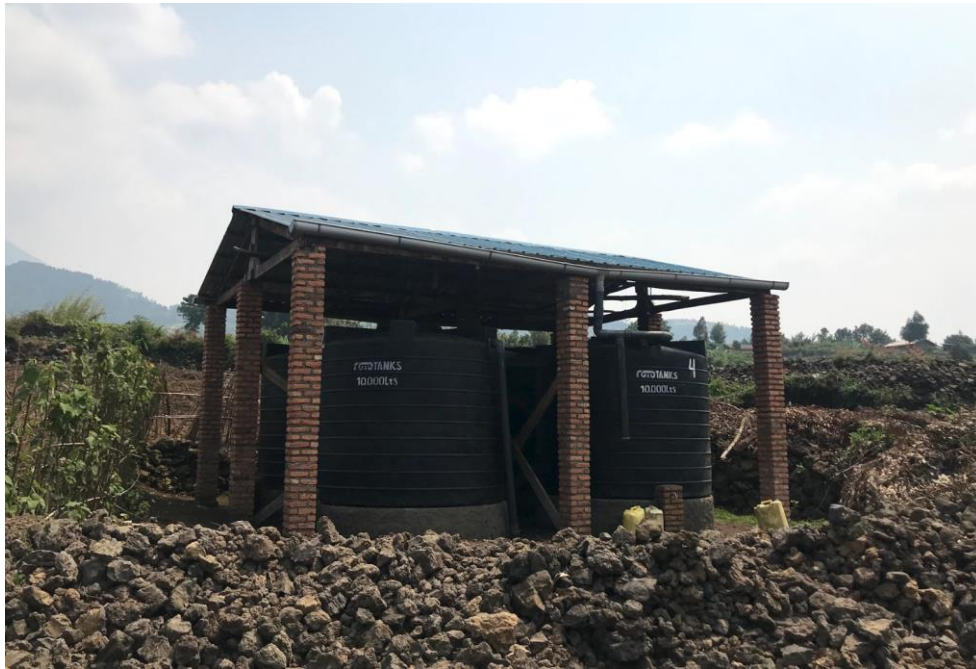
Photo 1: A previous system implemented at the village of Kibaya in 2018.
