Report on the Carania Dams Development 2016-2024: old and new

Authors: Kevin Lane & Mario Advíncula Zeballos

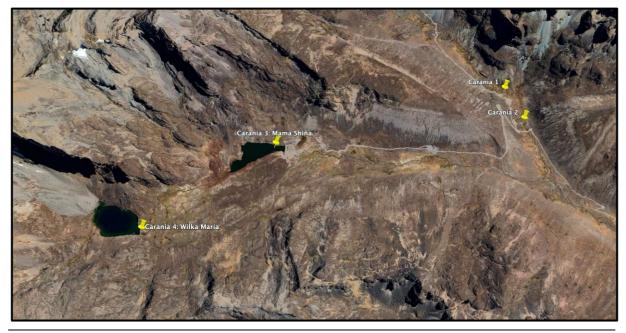
Figure 1: Map of Area showing Carania dams 1-4

Here we present the case of the Carania dams (Figure 1) in the Nor-Yauyos region which represent three old dams (Carania 1, 2, 4) and a new dam (Carania 3) which has displaced an older dam now partially submerged by the new basin. These dams are part of the *Cultural Archaeological Landscape of Carania*, which includes the Cuñepampa and Quepala sectors. Nonetheless, the failure of the modern dam of Carania 3 has meant that remedial works on the dam have necessitated the re-use of the older Carania 3 dam to hold back water so that essential repairs on the modern Carania 3 dam can be effected.

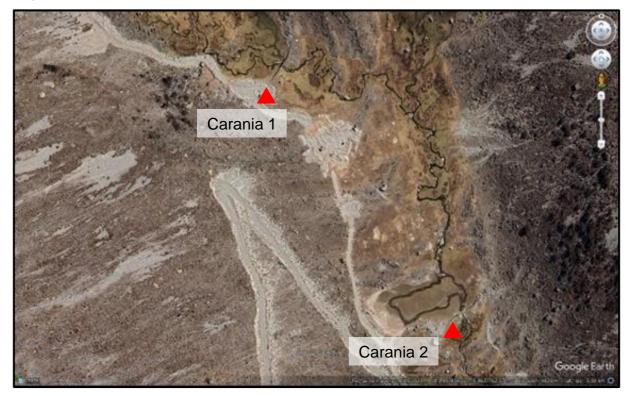
Carania 1 and 2 have been partially affected by recent earthworks and the construction of a dirt leading to Carania 3, just slightly west end of the dam wall themselves (Figure 2 & 3).

Figure 2: Satellite image showing the location Carania 1 and 2 in the Quepala sector. Note new dirt road and evidence of earthworks related to the Carania 3 concrete dam project

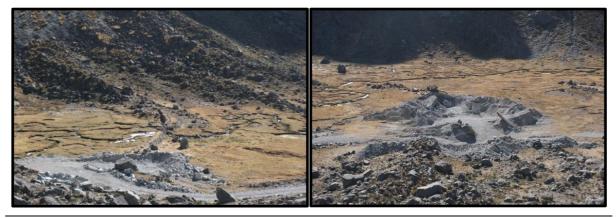
Figure 3: (Left) Carania 1 (lower section of Quepala Creek), earth quarrying can be seen next to the recently opened dirt road. (Right) Detail of earth quarry next to Carania 1

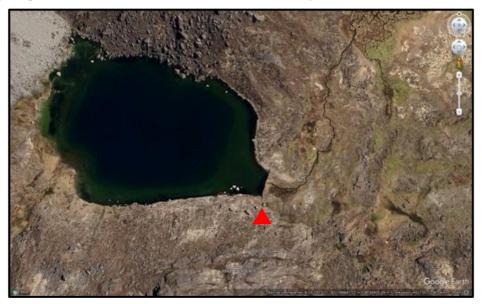
The quarrying and road building is primarily to build access for the Ministry of Agriculture's (MIDAGRI) *Sierra Azul-Punche Peru* project which aims to construct new concrete dams at these four points (Carania 1-4), of these Carania 3 has already been built. Carania 4 (Figure 4) has not yet been impacted but the dirt road has been extended to it and

plans are afoot to build a new concrete dam here too. These construction plans will negatively impact the ancient dams, in most cases leading to their destruction.

Figure 4: Satellite image showing the location and layout of Carania 4, in relation to the Wilka María lake. The image does not yet show the new dirt road that has recently been opened to access the dam and the site where a new concrete dam, similar to the one at Mamá Shiña lagoon, is planned to be built

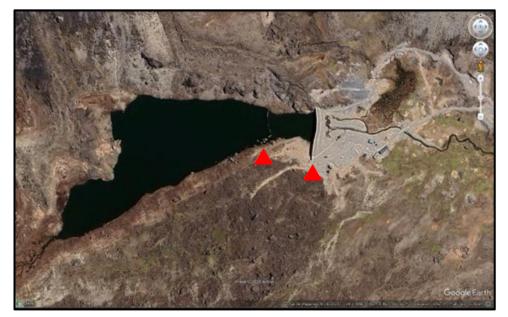
As mentioned above, Carania 3 (Figure 5) has already been built funded by Gobierno Regional de Lima¹. Carania 3 is a new concrete dam built *c*. 90 m east of the old dyke. The rising water of the new dam submerges the old dam, severely affecting its integrity and general state of preservation. Carania 3 is a prime example of what can, and often does, go wrong with modern cement dams.

Figure 5: Satellite image showing the location and layout of Carania 3, in relation to the Mama Shiña lake. Left triangle shows the submerged old dam and the right triangle the new dam built built by

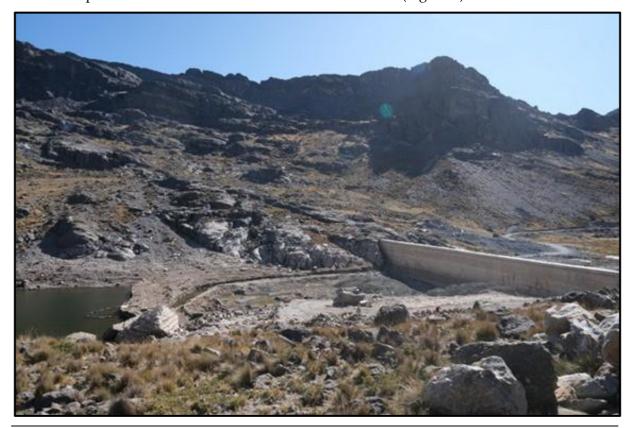
Work on Carania 3 commenced in 2016 and supposedly finished in 2023. Nevertheless, with the onset of the most recent rainy season (November 2023-April 2024) the dam was seen to lose considerable water, negatively impacting on its integrity and longterm potential. The main problems seem to have been that the base wall was too thin and that the prime materials used on the construction were substandard. Therefore, in 2024 the older Prehispanic dam was patched up to hold water back from the new dam so that essential repairs could be undertaken on the new Carania 3 (Figure 6).

Figure 6: Old Carania 3 (left) shored up to hold water while essential repairs are undertaken on the new Carania 3
