Completion Report

2024 Rural Community Well Restoration Program

Kadapa District, India

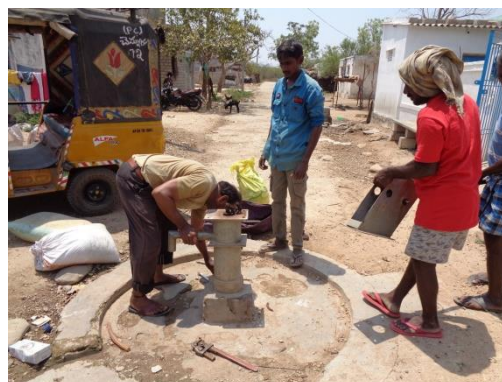
The technician removed the old head assembly, hand assembly & GI pipes for replacement.

Material Replacement: Under the technician's expert guidance, the project initiated the removal of old and worn components. This included the dismantling of the old head assembly, hand assembly, and the extraction of all GI pipes. These aging and deteriorated materials were subsequently replaced with brand-new components, ensuring the bore well's optimal functionality and longevity.

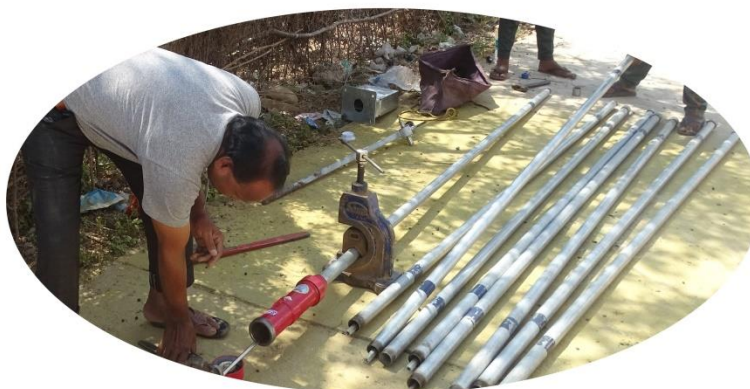
Pedestal: A durable pedestal was sourced to provide stability and support to the bore well setup.

MKII Cylinder Assembly: The project secured the MKII cylinder assembly, a critical component essential for the bore well's operation and water extraction.

GI Pipes (Galvanized Iron): A supply of good quality GI pipes, complete with connecting rods and couplings, was obtained to replace the aging pipe infrastructure within the bore well. These pipes are crucial for efficient water transportation.

Handle Assembly: The purchase included the handle assembly, a key element in facilitating the manual operation of the bore well.

Water Tank Assembly: A water tank assembly was procured to install to the Hand pump Borewell.

Head Assembly: The project also acquired a new head assembly, which plays a pivotal role in controlling and managing the water flow from the bore well.

Nuts and Bolts: Various nuts and bolts, essential for assembling and securing the bore well components, were obtained in the required quantities.

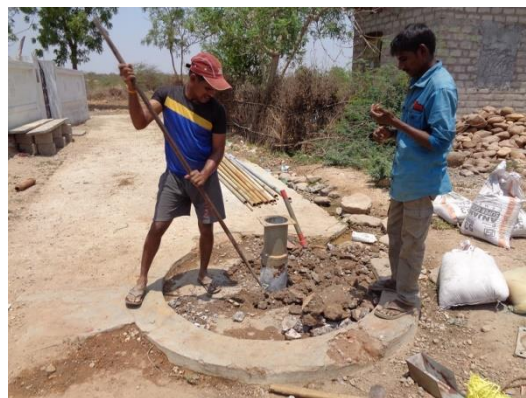
(iii) Removal of damaged platform (apron)

Comprehensive Removal: The masons systematically and thoroughly removed the old and damaged platform & pedestal that had served their purpose but were no longer safe or functional. This meticulous approach was essential to guarantee the safety of the communities.

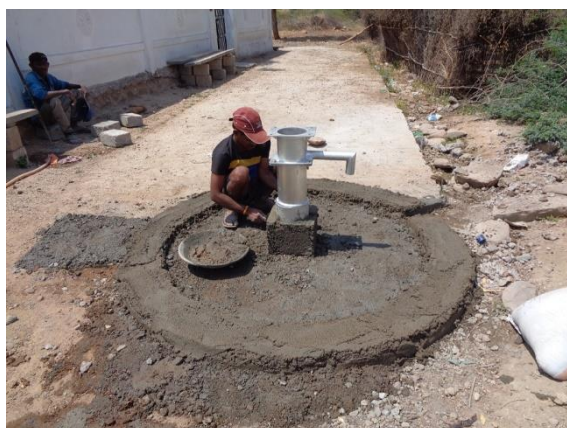
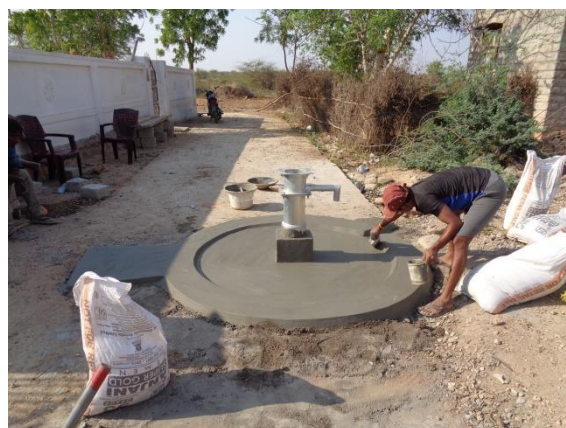
(iv) Construction of a sturdy platform and efficient water run-off channel

Construction and completion of new platform

Following the borewell's restoration, the mason initiated a comprehensive construction phase, involving the installation of a new pedestal and the creation of an efficient water run-off channel. First, skilled technician securely fitted a new pedestal, also known as an apron, over the borehole, ensuring structural support and safeguarding the borewell's integrity. The construction team then meticulously built robust platform around the borewell, using a combination of bricks, gravel, sand, and cement for longevity and stability. Strategically placed reinforcements around the casing and pedestal further enhanced stability. These activities not only restored the borewell but also established resilient and well-designed infrastructure, enhancing functionality and safety for the benefit of the communities served.

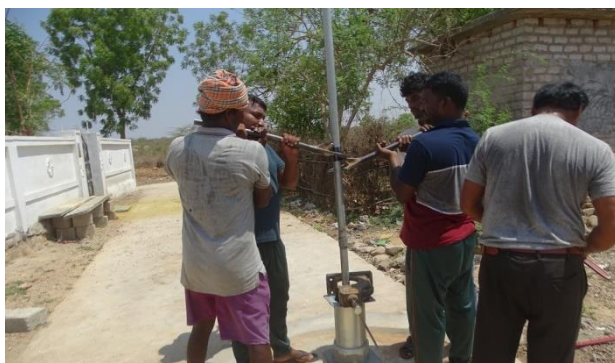
Technician & village volunteers are inserting the G.I.pipes.

The borewell restoration efforts, led by the skilled technician in collaboration with dedicated village youth volunteers, encompassed a comprehensive set of actions in the target village. These activities included the meticulous replacement of the old, broken cylinders with brand-new ones, ensuring the borewell operated at peak efficiency. Additionally, they replaced the worn-out Head assembly with a new one, enhancing control and water flow management. The team also tackled the replacement of all damaged G.I. (Galvanized Iron) pipelines with fresh counterparts, guaranteeing the integrity of the water transportation system. Furthermore, the old and deteriorated water tank is swapped out with a new one. Lastly, the worn-out handle is also replaced with a new, sturdy handle, enabling smooth and safe operation of the borewell in the village. These comprehensive restoration actions not only revitalized the borewell but also fortified its long-term functionality, serving as a testament to the collaborative efforts of the community and project team in ensuring sustainable access to clean water.

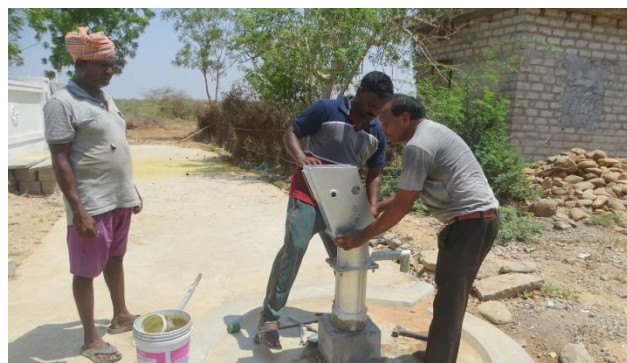
Technician and the volunteers are fixing the bore head.

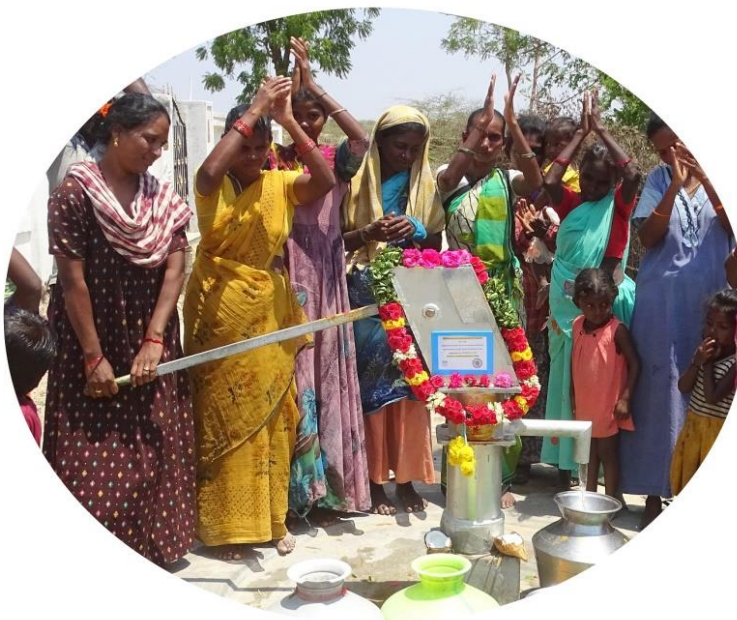
(vi) Completion of Borewell's restoration and utilization by the community:

Following the meticulous restoration efforts, the borewell in the target village has been fully restored to working condition and is now actively serving the needs of the community. These comprehensive restoration actions have revitalized the borewell, ensuring its optimal functionality. As a result, the community now enjoys reliable access to clean and potable water, addressing a fundamental need for the residents of the village. This marks a significant milestone in the project's mission to enhance the quality of life and well-being of the local population by providing a sustainable and dependable source of clean water.

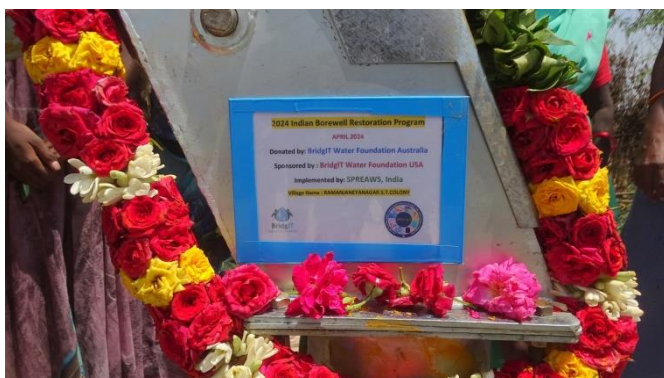
(vii) Installation of Signage Name Plaque

On restoration completion, the name plaque is installed on the wellhead, so that beneficiaries know the name of the sponsor, donor, and contacts for the implementing partner.
