# **Rural Community Well Refurbishment Program** Safe Water for Rural Communities, Mukono Region, Uganda

Duration: 1<sup>st</sup> May 2022 to 20<sup>th</sup> June 2022

Managing Partner: BridgIT Water Foundation, Australia Implementing Regional Partner: Suubi Community Projects, Uganda

In May 2022, SCPU received a grant from BridgIT Water Foundation Australia (BWF) under the sponsorship of **The Webber Family Foundation** for the refurbishment of **7 community water wells in Mukono District.**

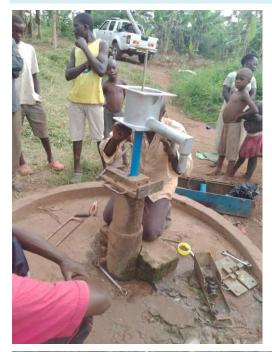
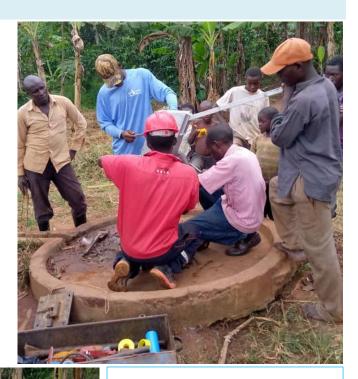
#### 1. Bamusuta A Village Well

No.	Community Name	Description	People Impacted
1.	Bamusuta A	<ul> <li>This borehole in Nabaale sub-county was donated to the community and the school by well-wishers, more than 20 years ago. It hasn't been functioning for the past 4 years after it had been vandalized.</li> <li>People resorted to using dirty water collected from swamps.</li> <li>Having repaired this well, the community can once again access clean water, with less burden. (125 households)</li> </ul>	750

Installation of new hand pump parts and signage.

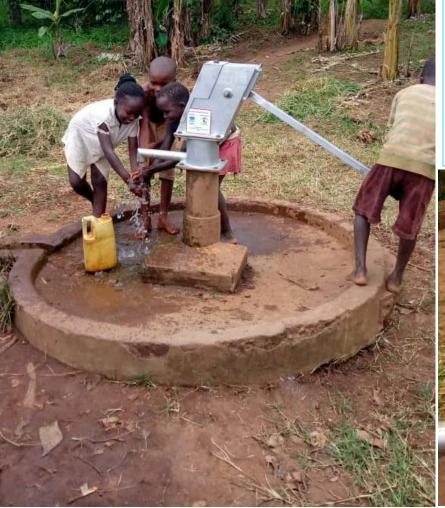
Bamasuta A village children use the completed refurbished pump.

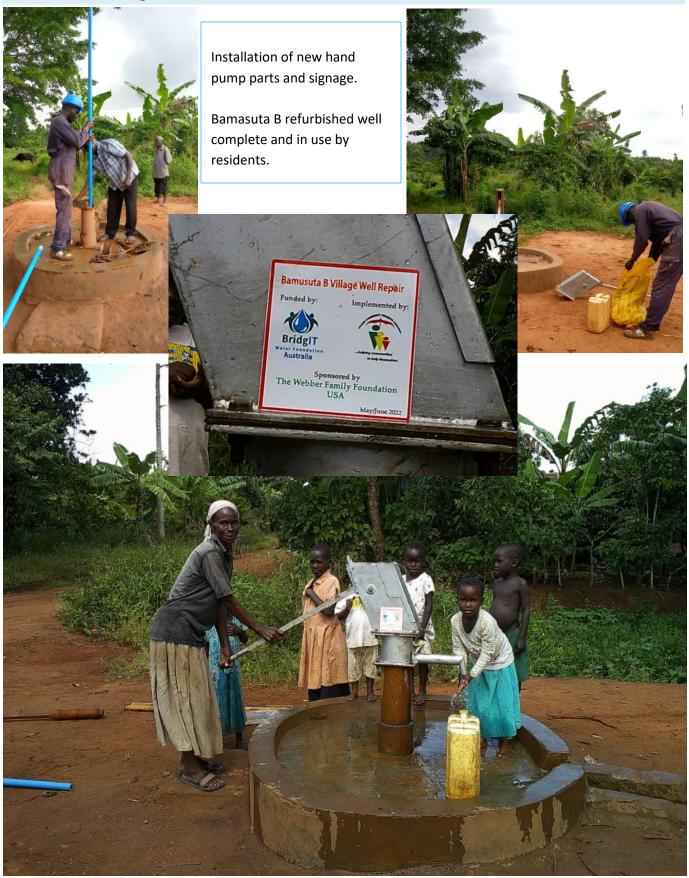
#### 2. Bamusuta B Village Well

2. Bamusu	Bamusuta B	This borehole in Nabaale sub-county was installed by the government more than 20 years ago and has been broken down for 3 years.	
		The refurbished borehole is located centrally in the village so that most households can access it less than 500mtrs away allowing people to wash their hands regularly as needed. A nearby school shall also be able to use the Well. (125 households)	750

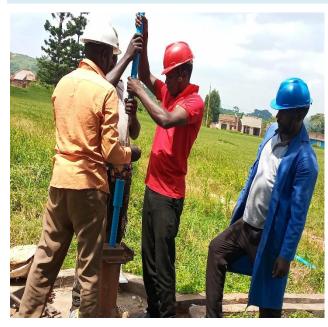
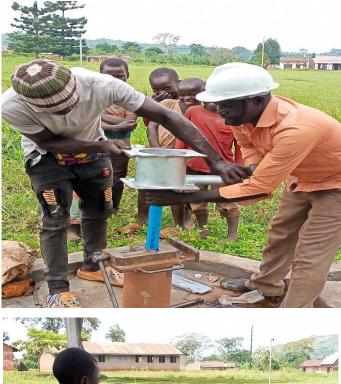
## 3. Kyajja Village Well

3.	3. Kyajja	This borehole in Nagojje sub-county was donated to the community and the school by well-wishers more than 20 years ago. It hasn't been functioning for the past 3 years after it had been vandalized by unknown people who stole some parts. People resorted to using dirty water collected from swamps.	1,000
		Having repaired this well, the community and school can once again access clean water, with less burden. (165 households)

Installation of new hand pump parts and signage.

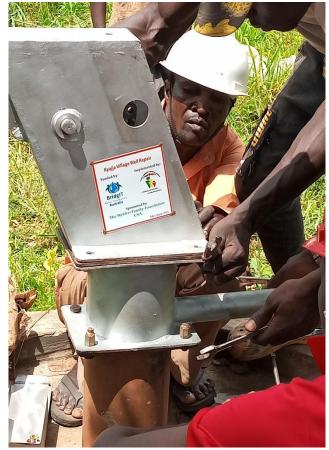
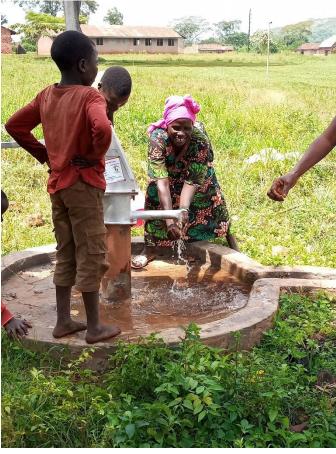
Kyajja village refurbished well complete and in use.

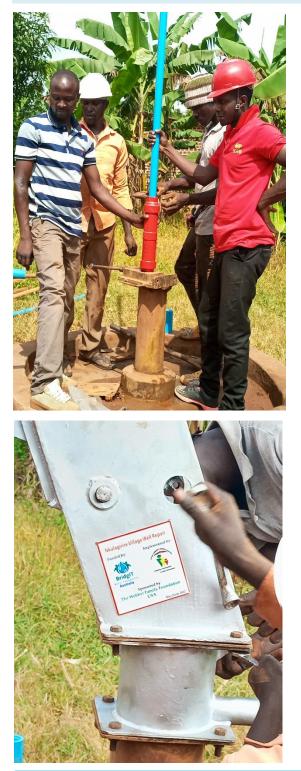
### 4. Nkulagirile Village Well

4.	Nkulagirire	This borehole in Nabaale sub-county was installed by the government more than 20 years ago and has been broken down for 4 years.	930
		The refurbished borehole is located centrally in the village so that most households can access it less than 500mtrs away allowing people to wash their hands regularly as needed. (155 households)

Installation of new hand pump parts and signage.

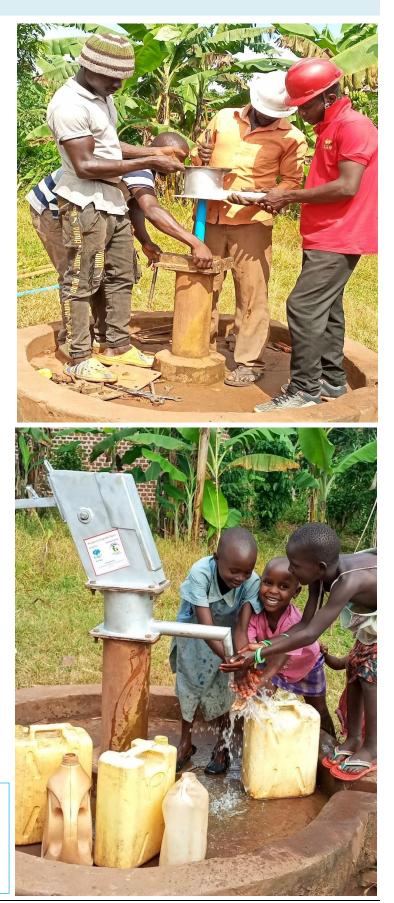
Nkulagirire village refurbished well complete and in use.

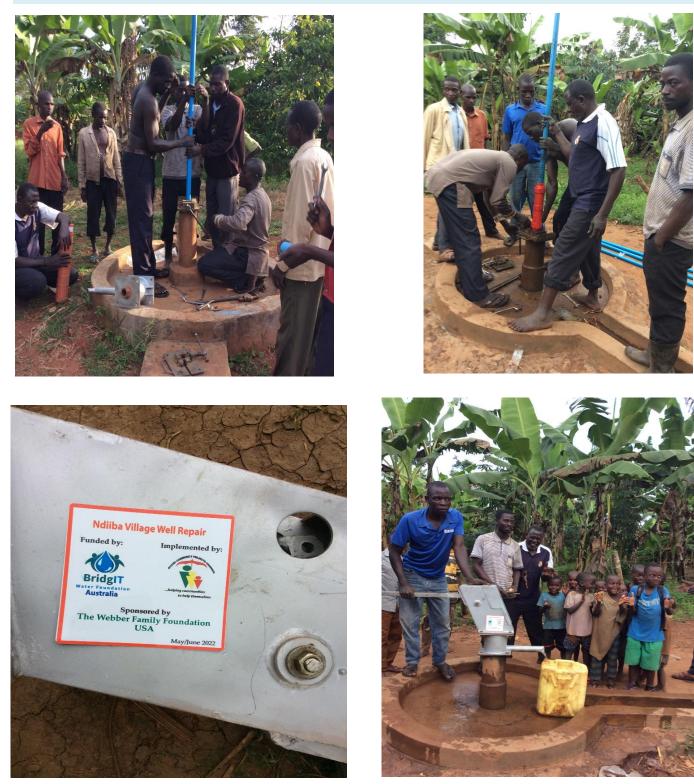
# 5. Ndiiba Village Well

5.	Ndiiba	<ul> <li>This borehole in Kasawo sub-county was installed by the Directorate of Water Development, more than 15years ago and hadn't been functioning for the last 5 years. Community members were collecting dirty water from streams approx. 3km away.</li> <li>The refurbished borehole is located centrally in the village so that most households can access it less than 500mtrs away allowing people to have water in their homes with less burden. A school in the village will also use this borehole as their main source of clean water. (98 households)</li> </ul>	560

Installation of new hand pump parts and signage.

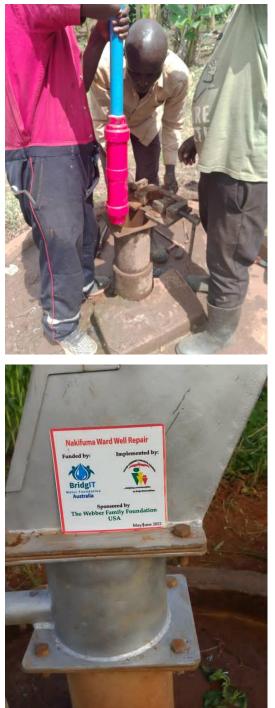
#### 6. Nakifuma Ward Well

6.	Nakifuma Ward	<ul> <li>This borehole in Nakifuma sub-county was installed by an Aid Agency more than 15 years ago and has been broken down for 4 years.</li> <li>The refurbished borehole is located centrally in the village so that most households can access it less than 500mtrs away allowing people to wash their hands regularly as needed. A nearby school shall also be able to use the Well. (150 households)</li> </ul>	900

Installation of new hand pump parts and signage.

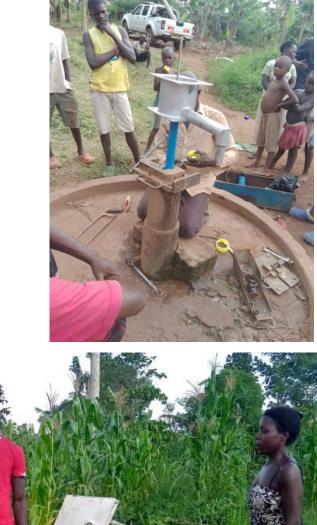
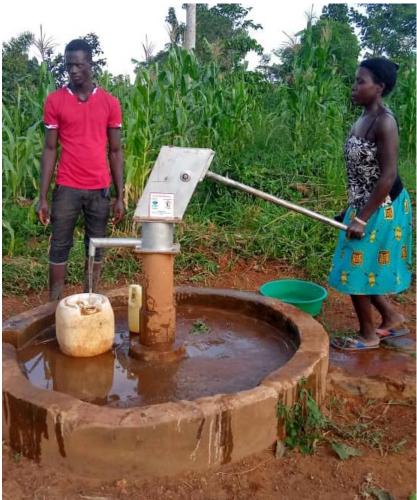
Video of Nakifuma Ward completed refurbished well in use.

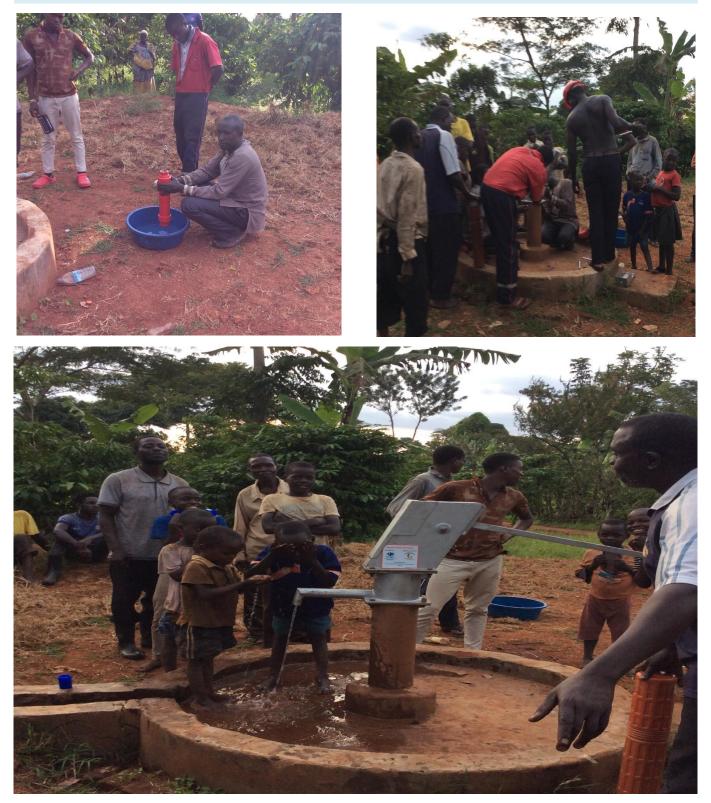
### 7. Kaganjo Village Well

7.	Kaganjo	This borehole in Nabaale sub-county was installed by the Ugandan government more than 15 years ago and has not been working for 3 years. Community members were collecting dirty water from streams approx. 2km away. (110 households)	660
	Totals	928 Households	5,550

Installation of new hand pump parts and signage.
